ST. LAWRENCE RIVER BASIN

# CRANBERRY LAKE DAM

## PHASE I INSPECTION REPORT NATIONAL DAM SAFETY PROGRAM

NY 00397

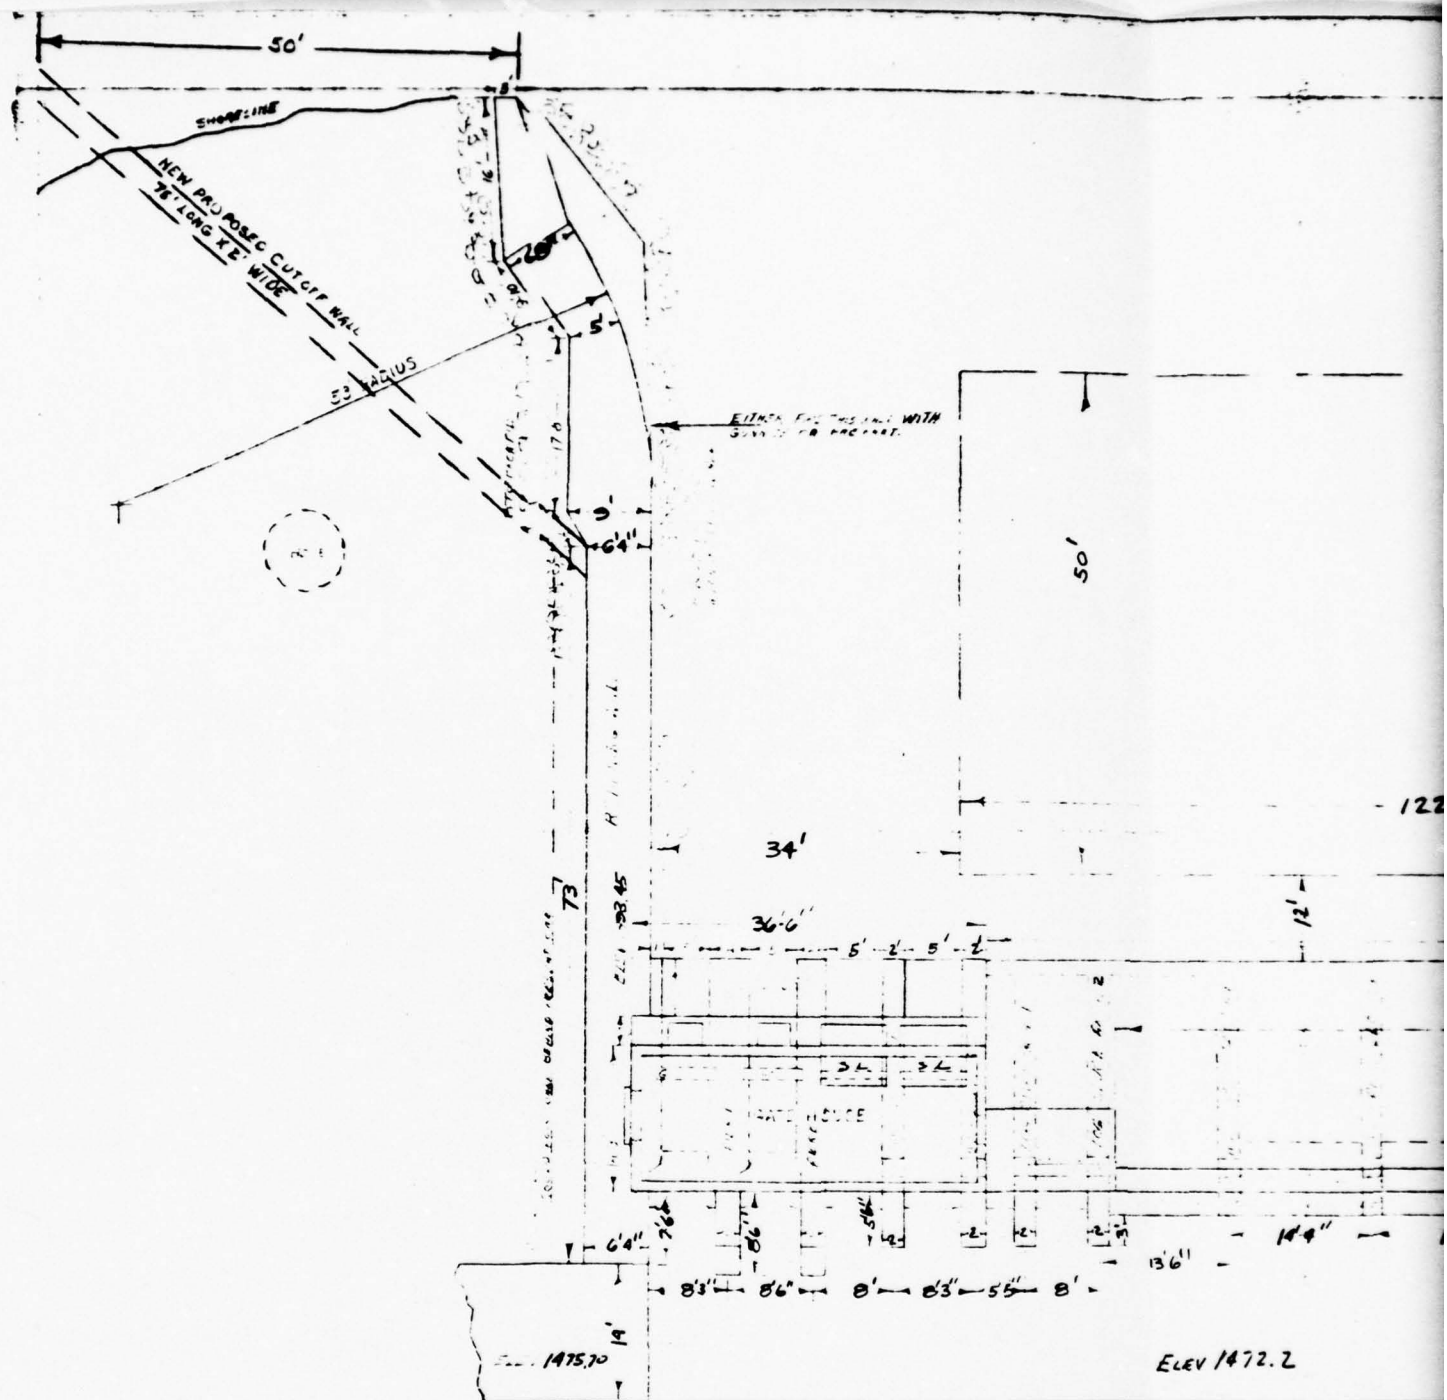
### FIGURE 4

The crest of the embankment is about 200 feet wide and is grass covered. A sinkhole-type depression was located in the embankment about 50 feet from the training wall and 100 feet from the upstream slope. The existence of a concrete cut-off wall (as shown on Figure 4) in the embankment could not be verified.
